INTEROFFICE CORRESPONDENCE

DATE: August 5, 1991

SUBJECT: OPERATIONS AND SURVEILLANCE REPORT CONCERNING THE SOUTH INTERCEPTOR
DITCH -- DSM-016-91

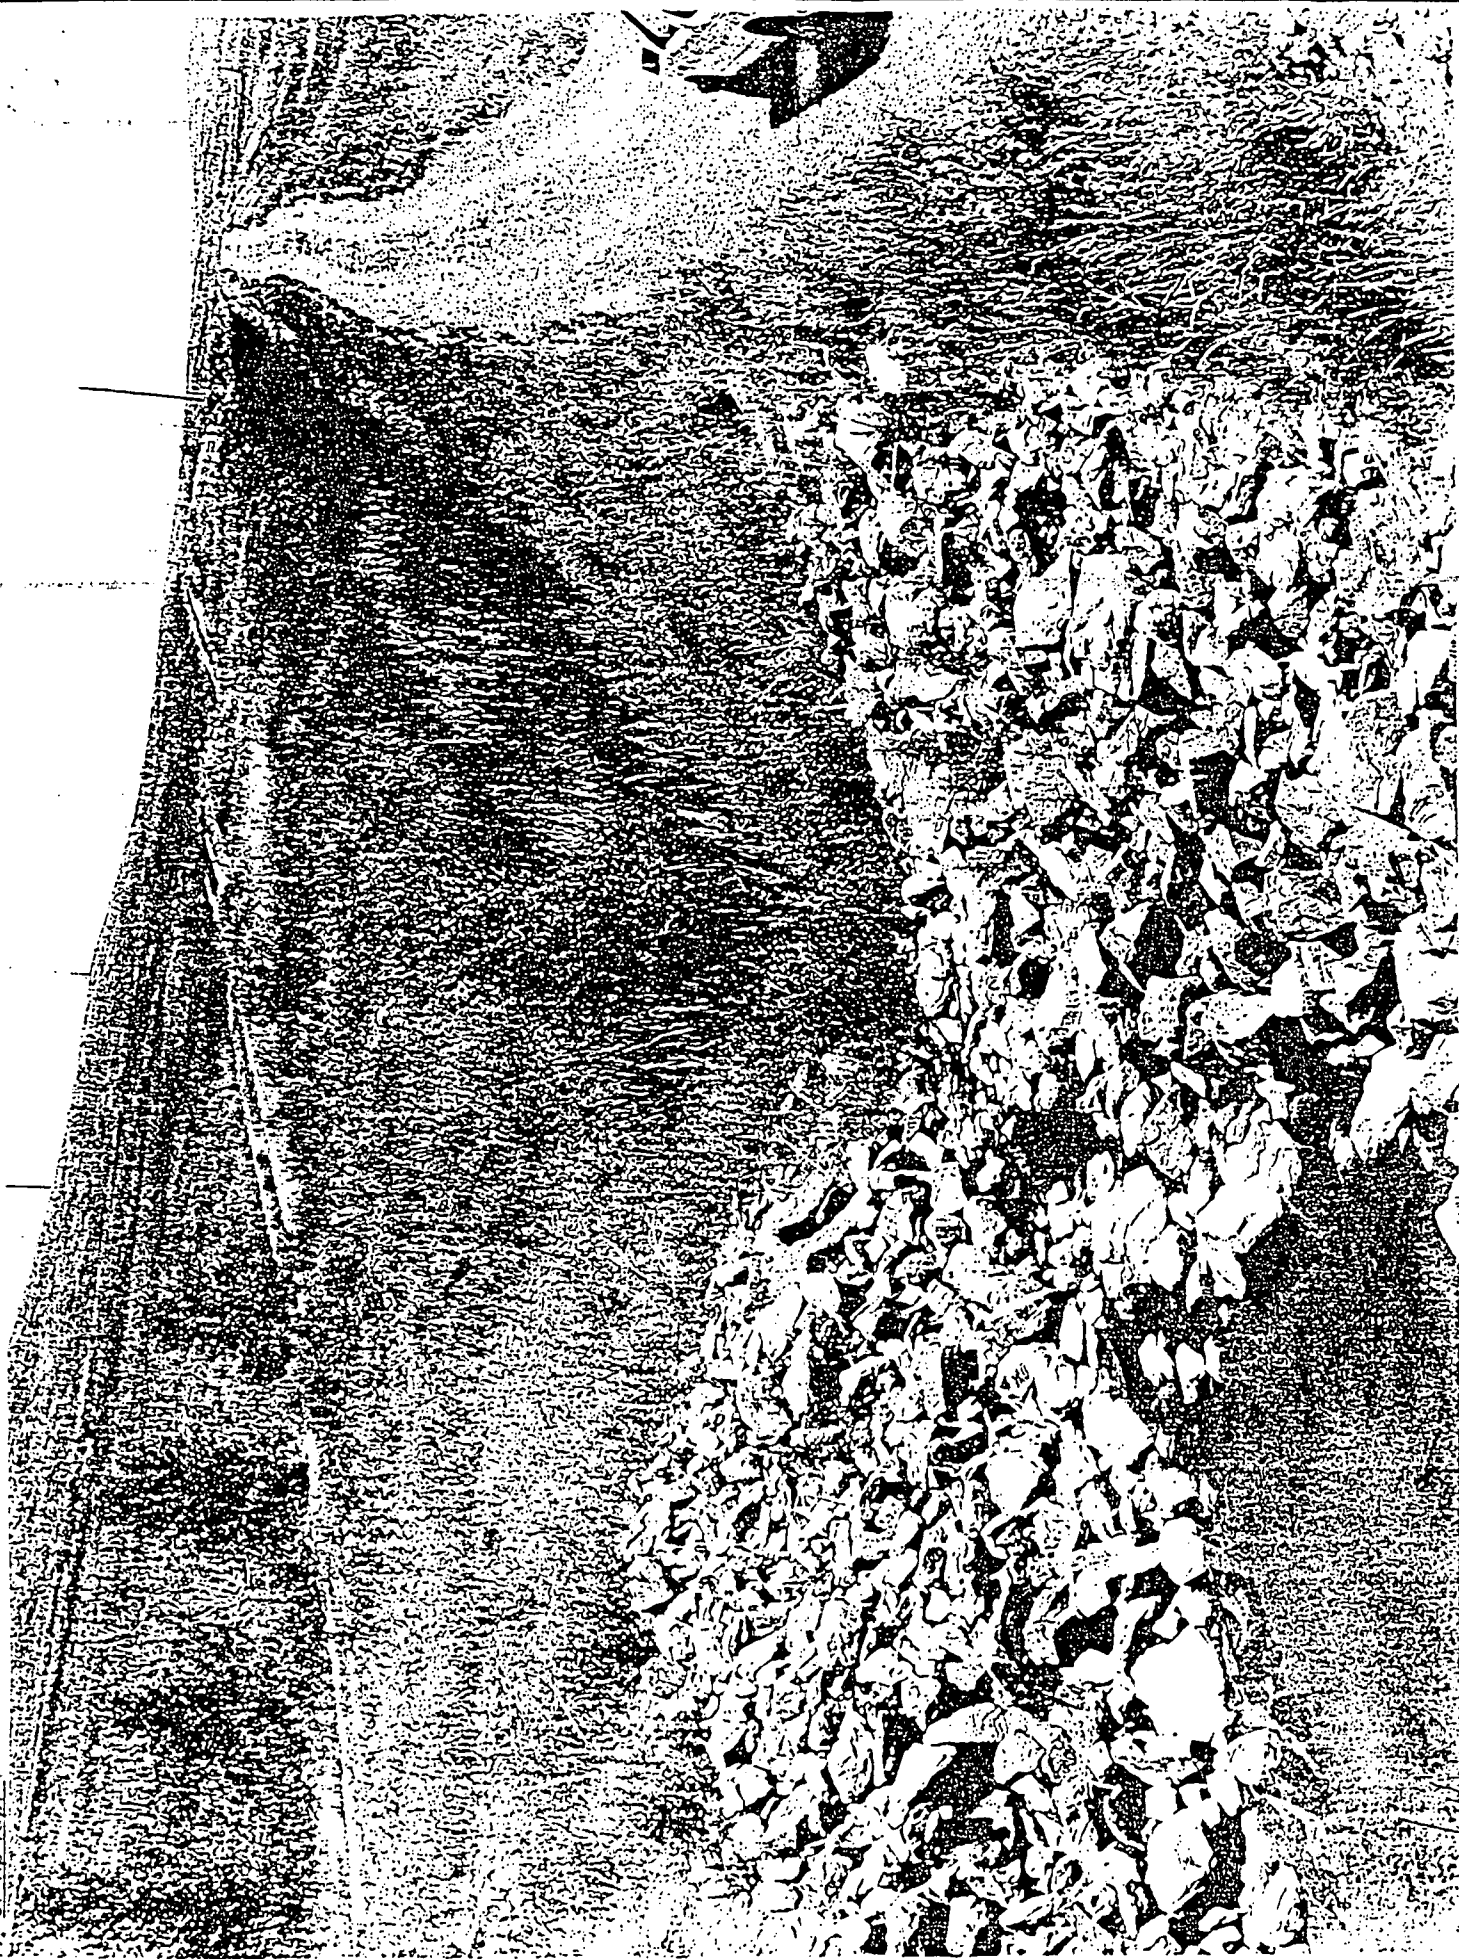
24. South Interceptor Ditch, East segment, East aspect. Note overall vegetation growth and condition of rip-rap.

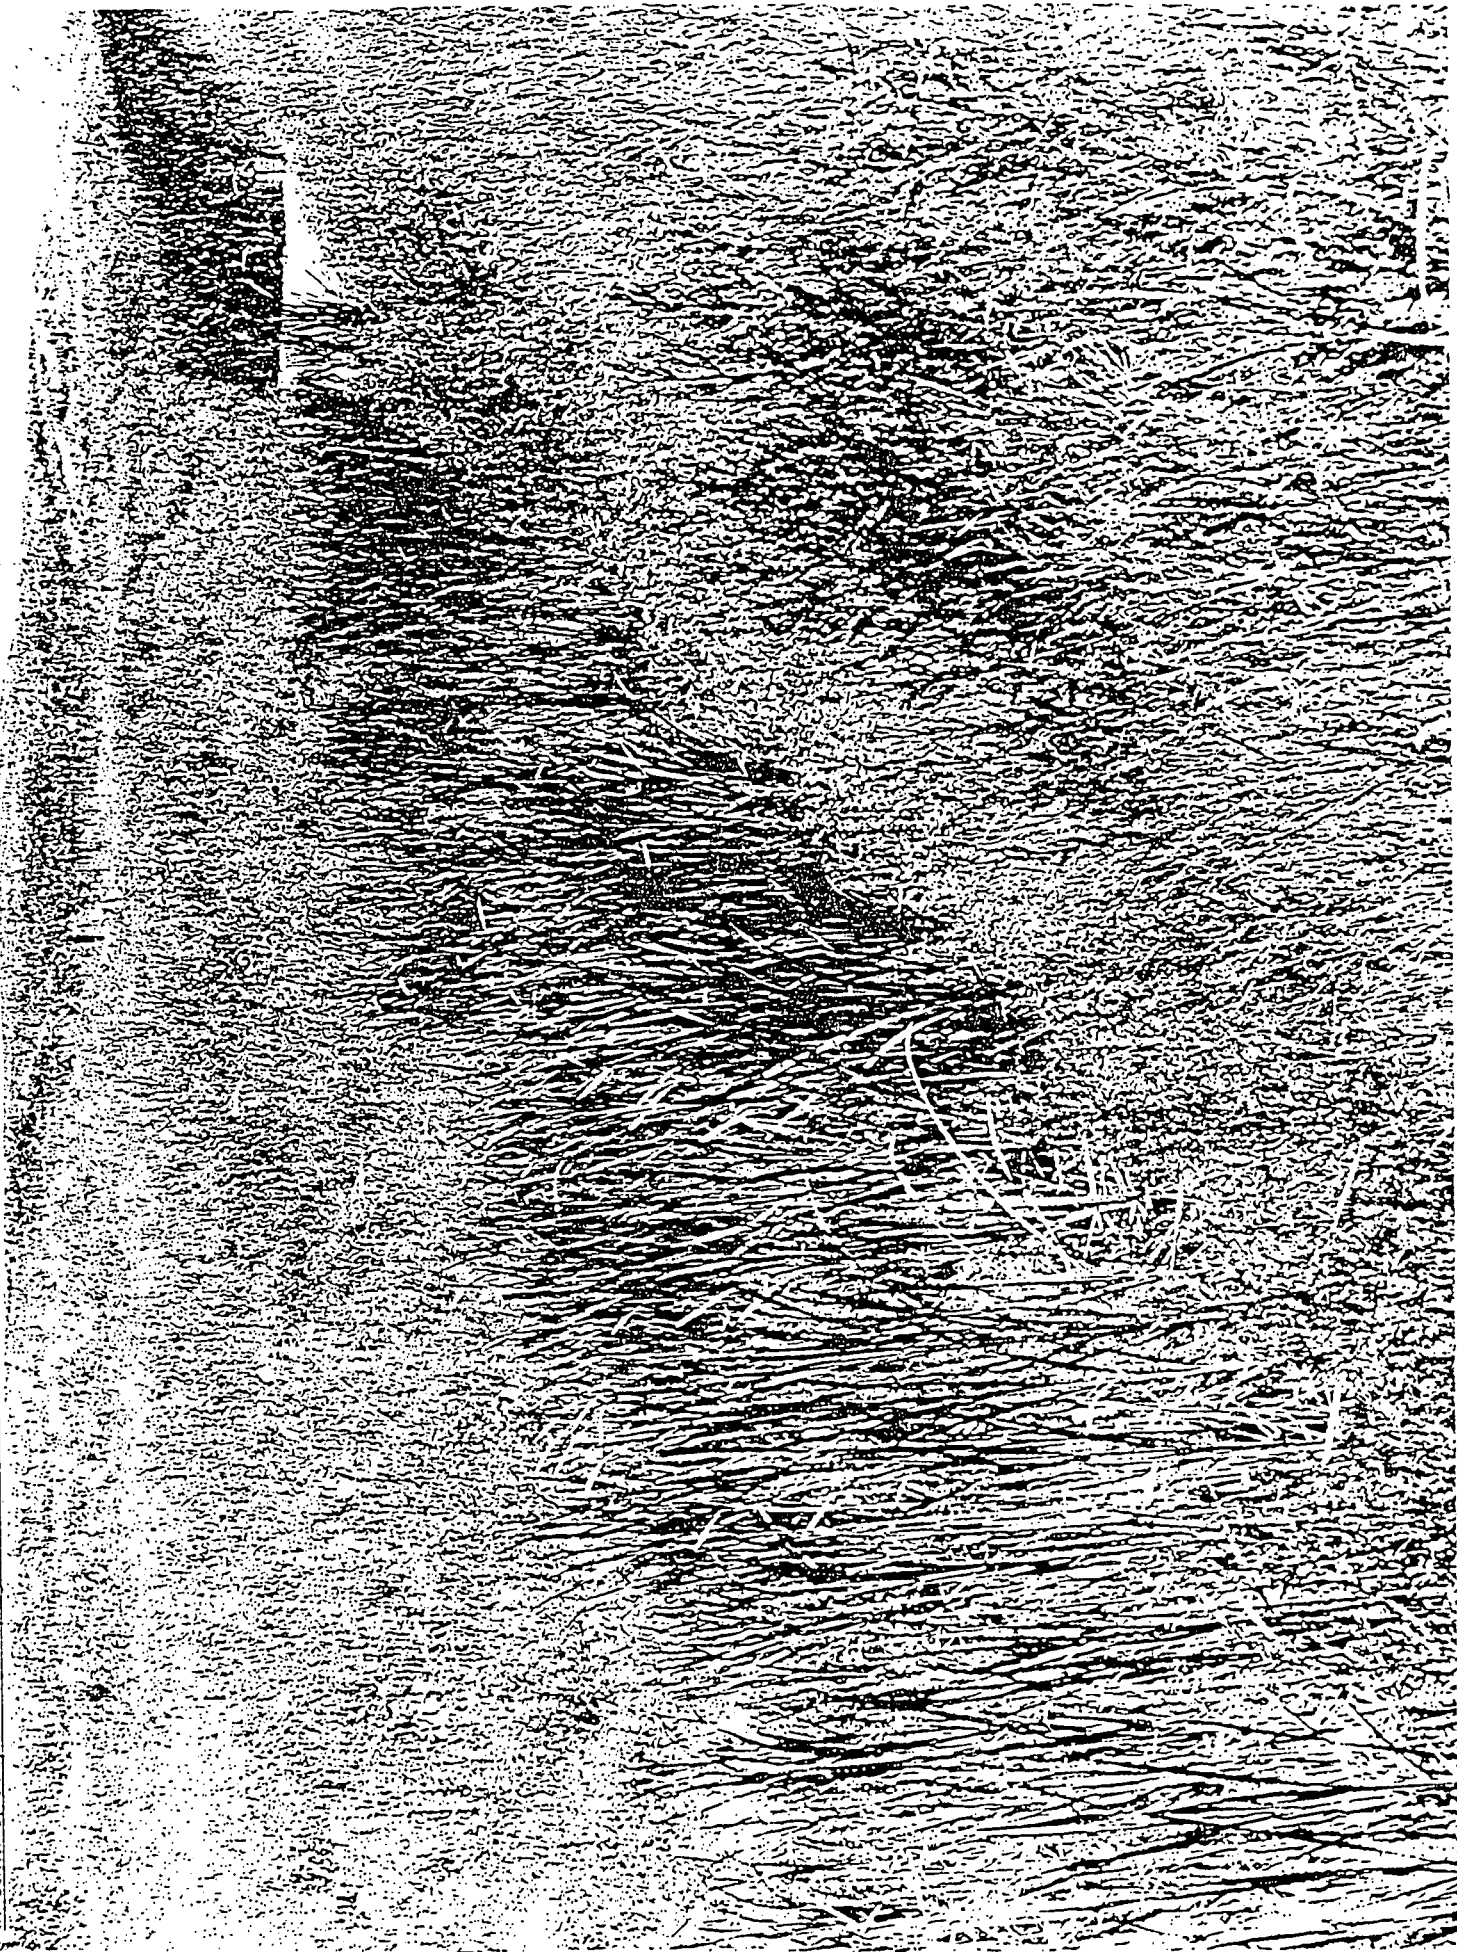
25. South Interceptor Ditch, East segment, East aspect. Note upper right portion of ditch that is devoid of cattails, suspected seepage area. Also notice amount of dead vegetation.

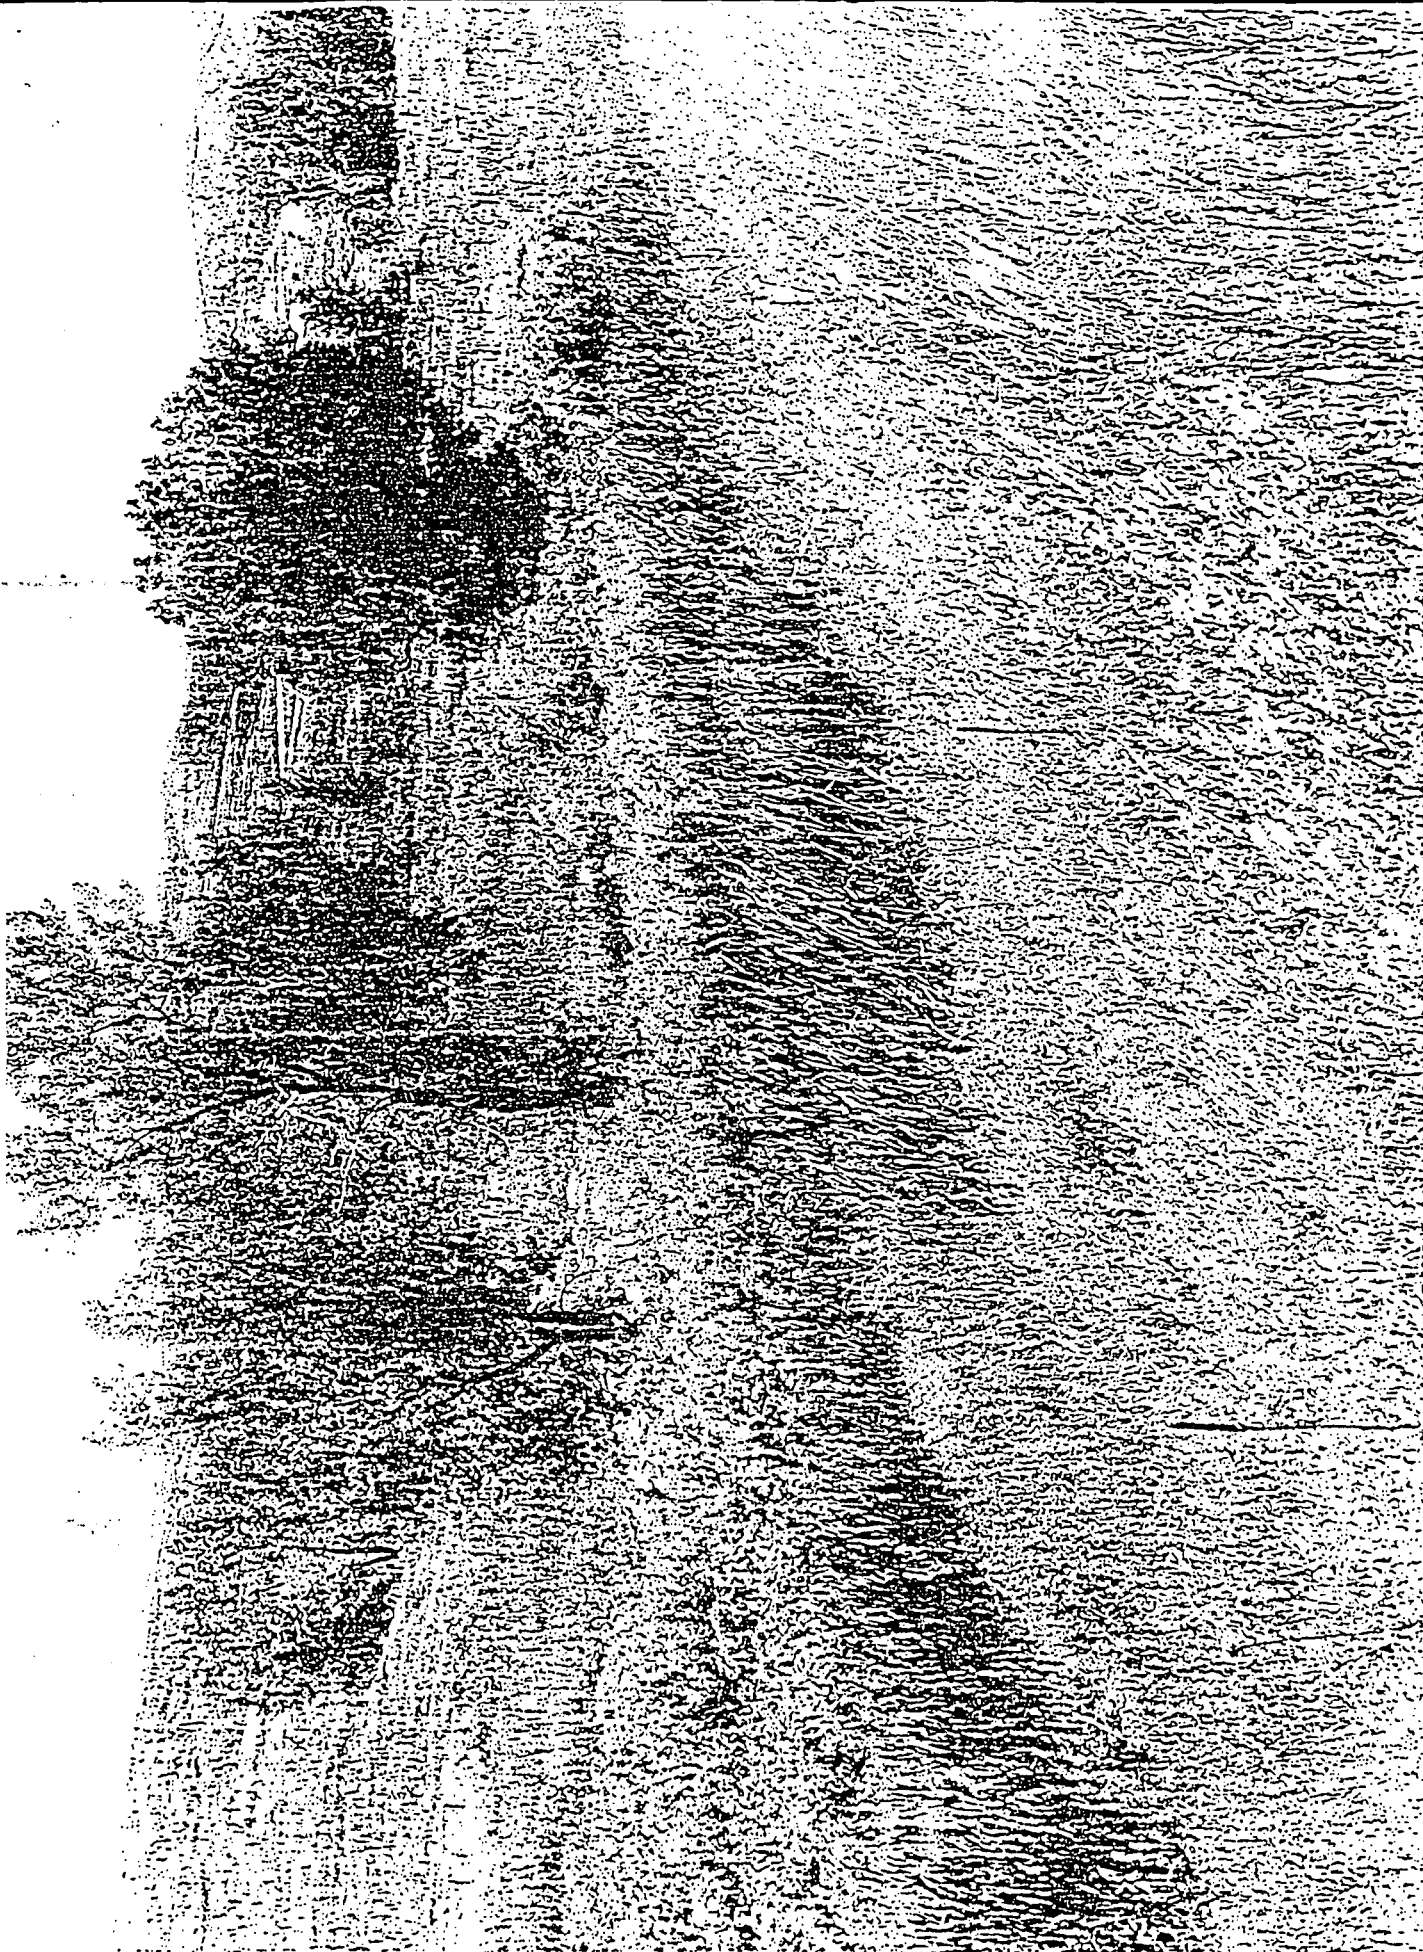
25. Down gradient of South Interceptor Ditch, East segment, West aspect, Overlooking Women Creek. Photo coincides with #25 depicting possible seepage area entering Women Creek. Note callails in foreground on ditch embankment vs. callails associated with Women Creek.

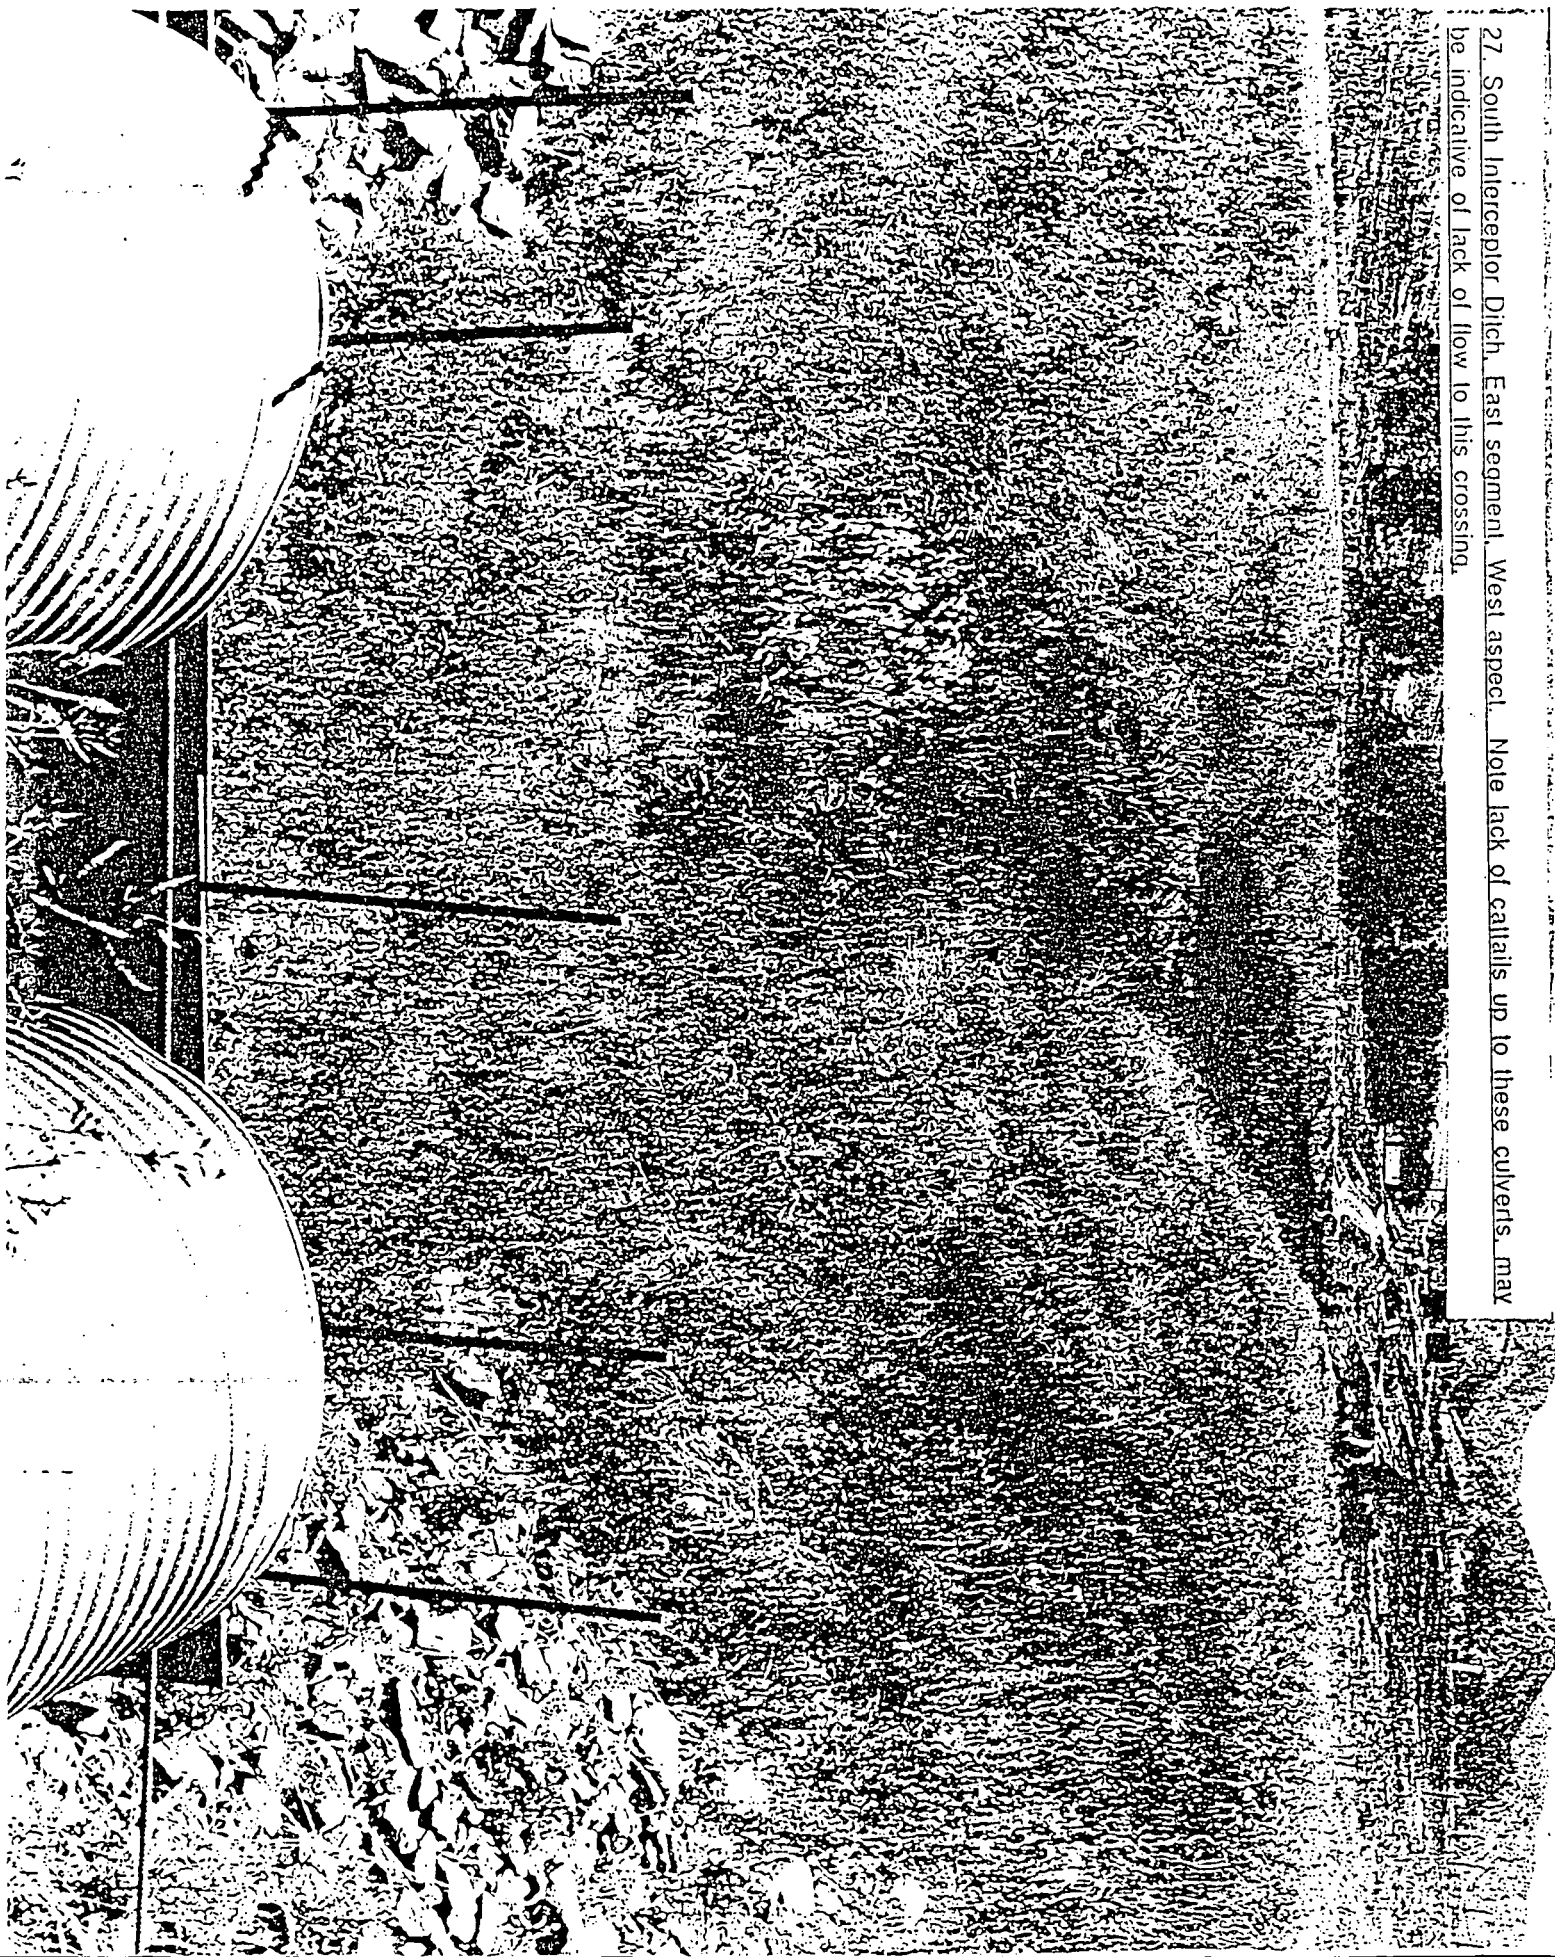
27. South Interceptor Ditch, East segment, West aspect. Note lack of cattails up to these culverts, may be indicative of lack of flow to this crossing.

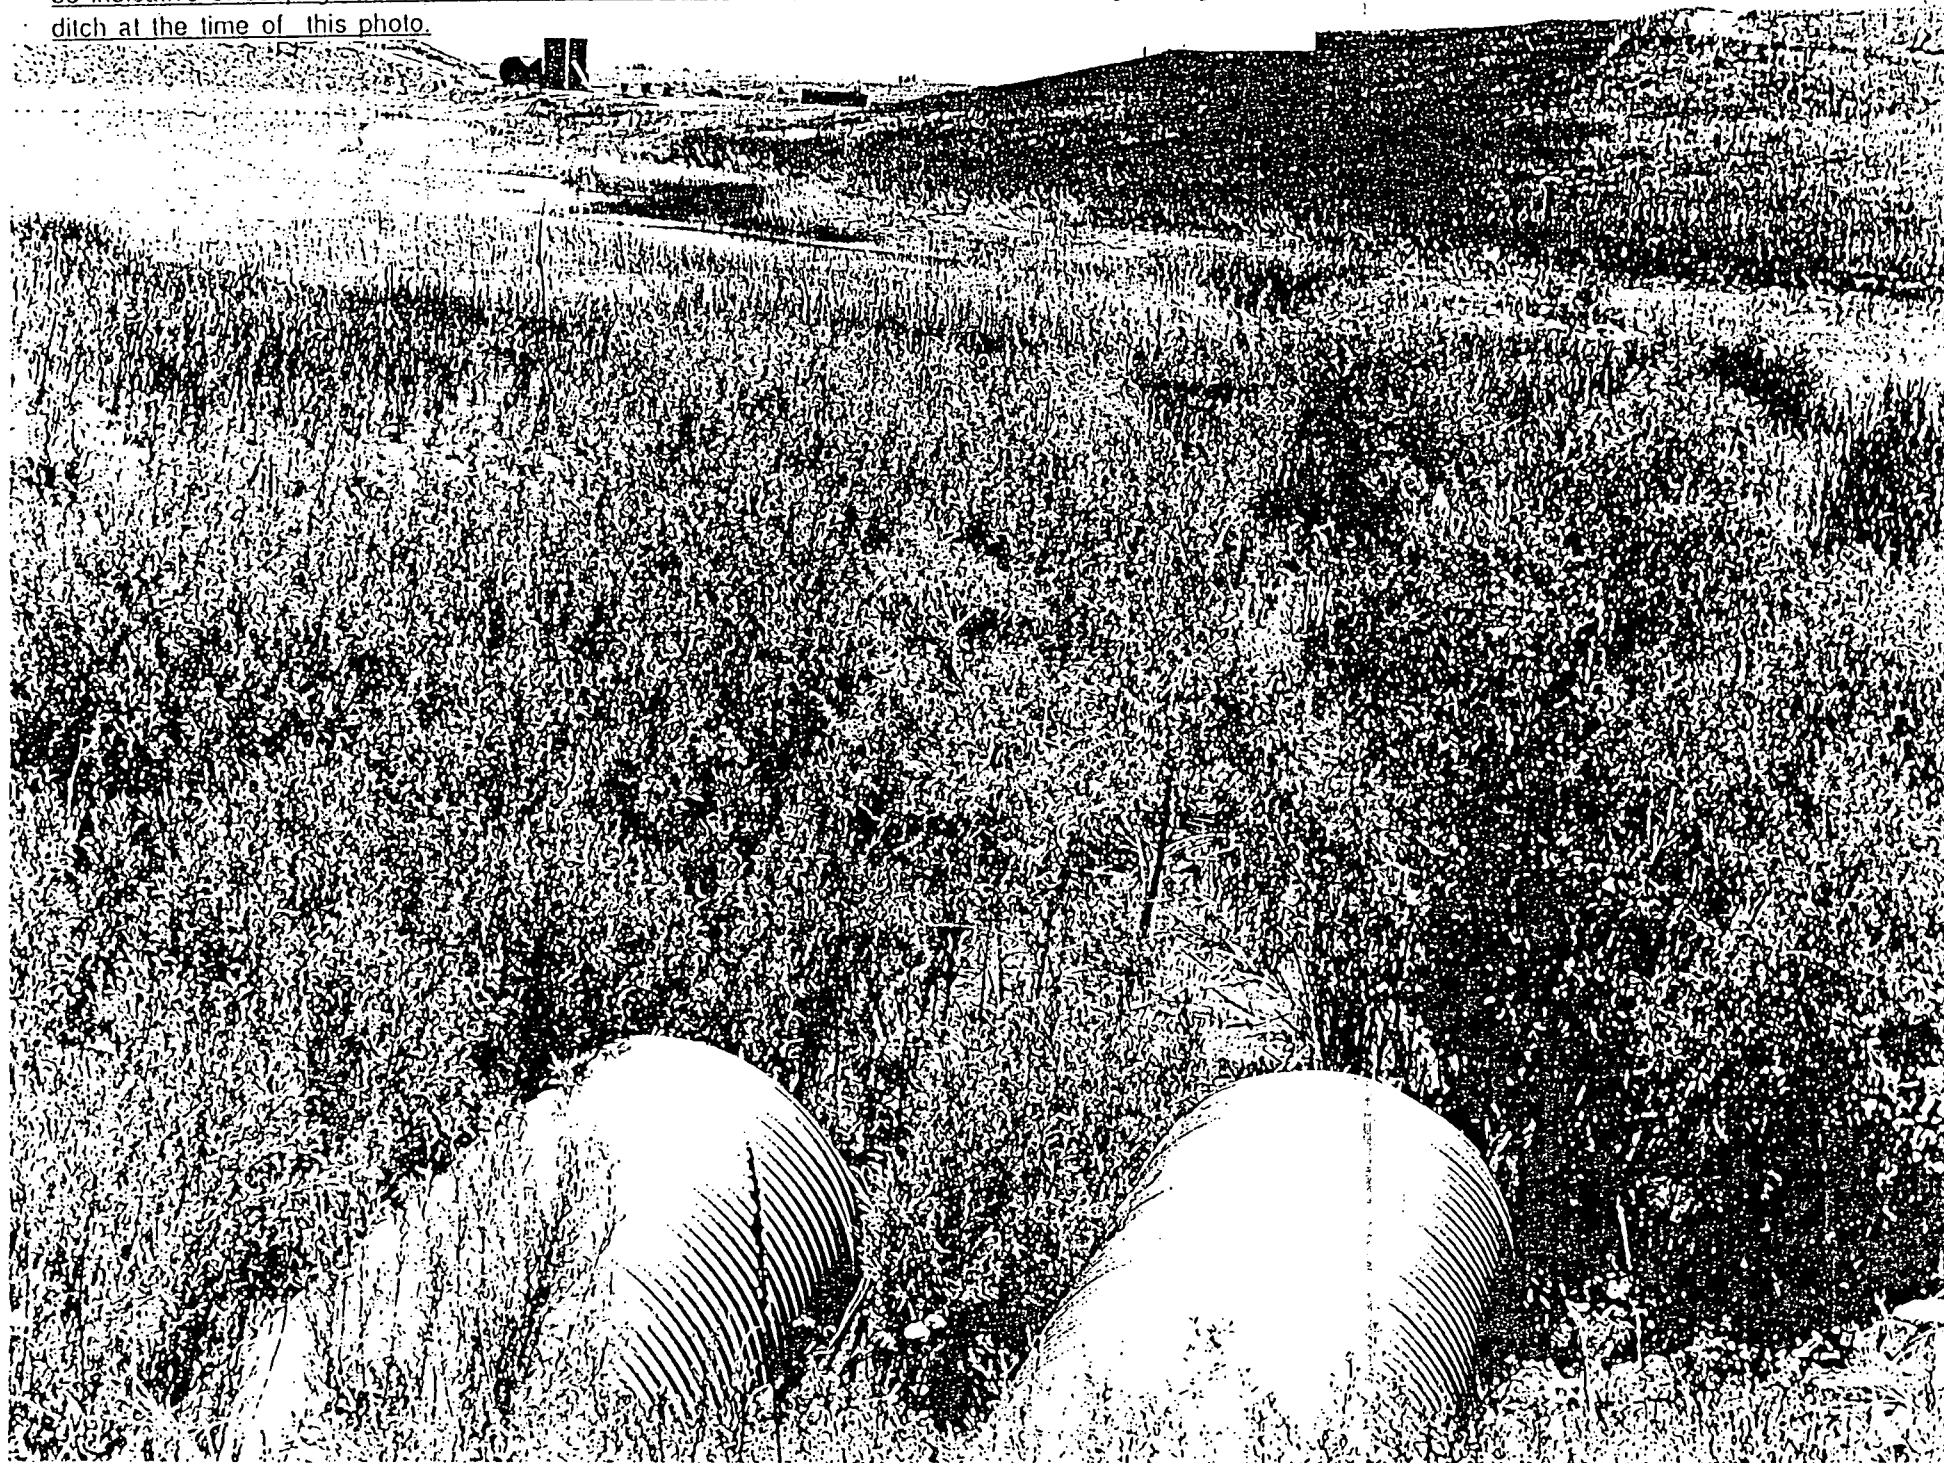
29. South Interceptor Ditch at Pond C-2. Note standing water near SID outlet to pond C-2, water may be indicative of seepage from Women Creek to Pond C-2 because water was not flowing through the ditch at the time of this photo.
